TECHNICAL REPORT N-76-6

## DEVELOPMENT AND EVALUATION OF CORRUGATED METAL FIGHTING HOLE COVER DESIGNS

Weapons Effects Laboratory  
U. S. Army Engineer Waterways Experiment Station  
P. O. Box 631, Vicksburg, Miss. 39180

May 1976

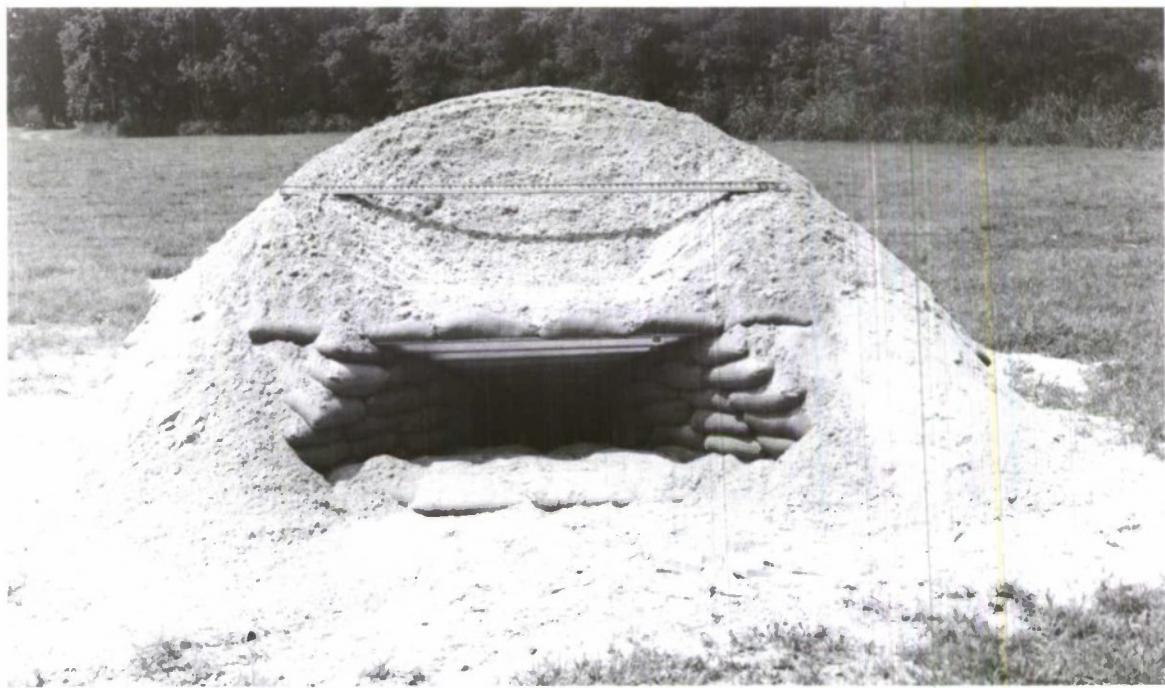
diameter (Figure 4.5a) and 8-1/2-inches deep (Figure 4.5b). However, the actual crater diameter and depth were impossible to establish due to the backslide of loose sand.

a. Diameter of crater approximately 6 feet

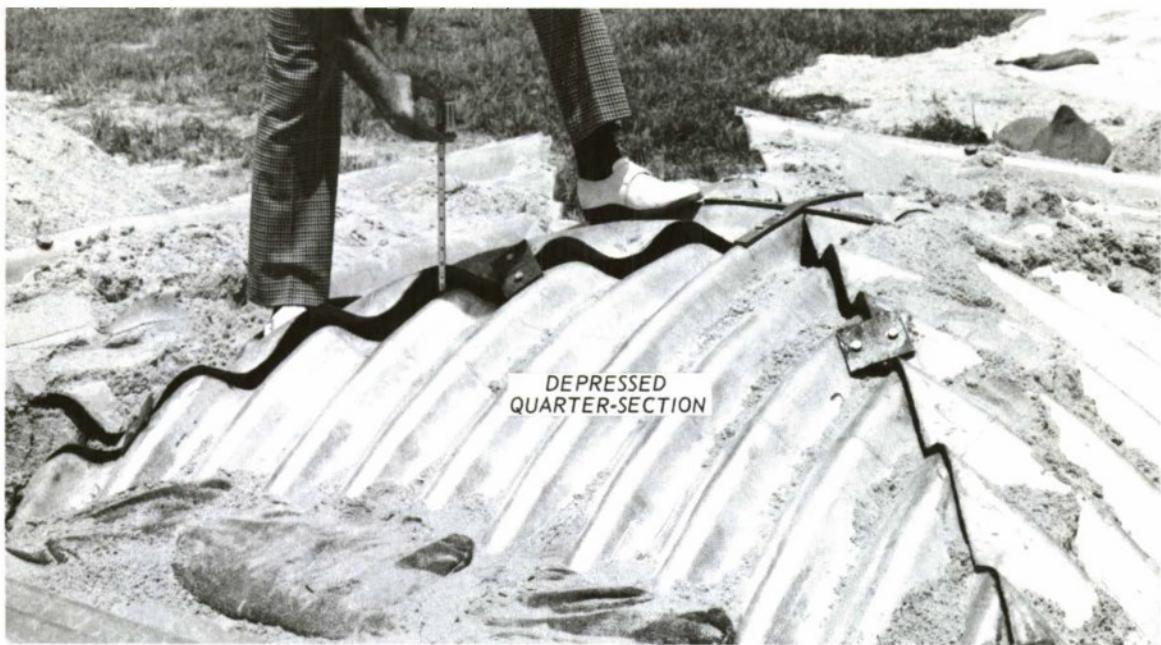
It was observed after removing the sand cover that the quarter-section of MICS above which the 4-pound charge of TNT had been centered was depressed in relation to the other quarter-sections (Figure 4.5c). This depression was a maximum of 2 inches (measured vertically) and occurred between the connection plates at the bottom of MICS and the crown of the bunker. Further examination revealed that this depression was a result of high stresses that occurred around the bolt holes used to connect the adjacent sections. Figure 4.5d shows the metal around a bolt hole that was deformed due to its resistance to the blast load on the quarter-section. In spite of the depression of the loaded quarter-section, sand was prevented from entering MICS by the sandbags placed over the seams of the adjacent section.

It was concluded that the weakest part of the bunker was the connection of the adjacent sections and that a 10-pound charge placed on the side of MICS would result in a catastrophic failure.

c. Damage to loaded quarter-section of MICS determined after removal of sand cover

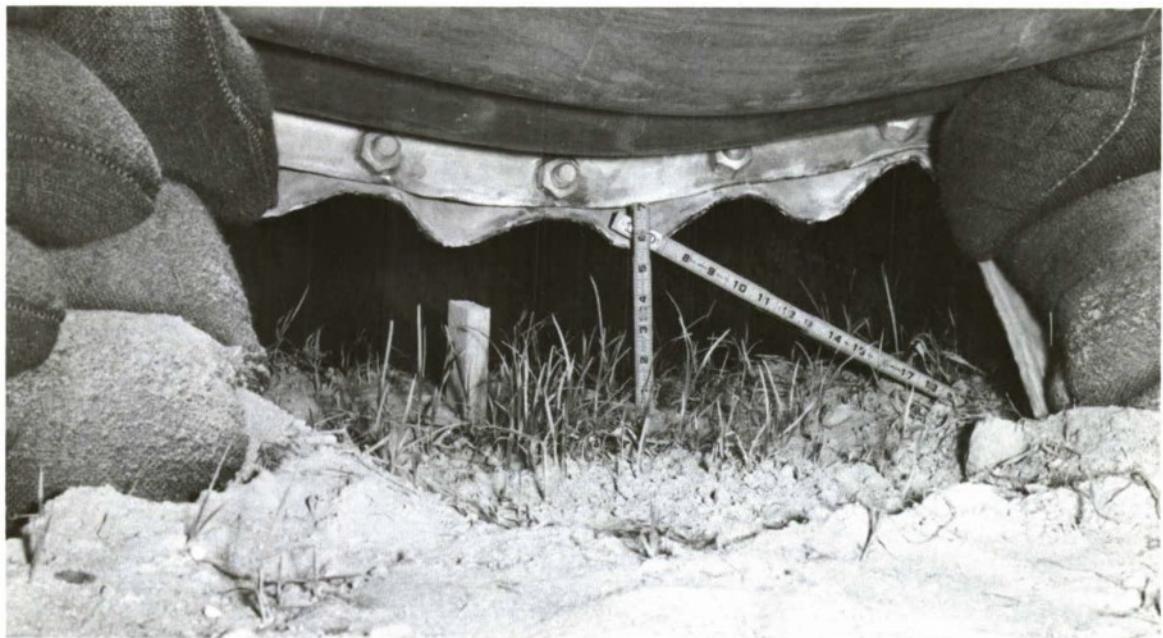
c. Aperture on loaded side of MICS

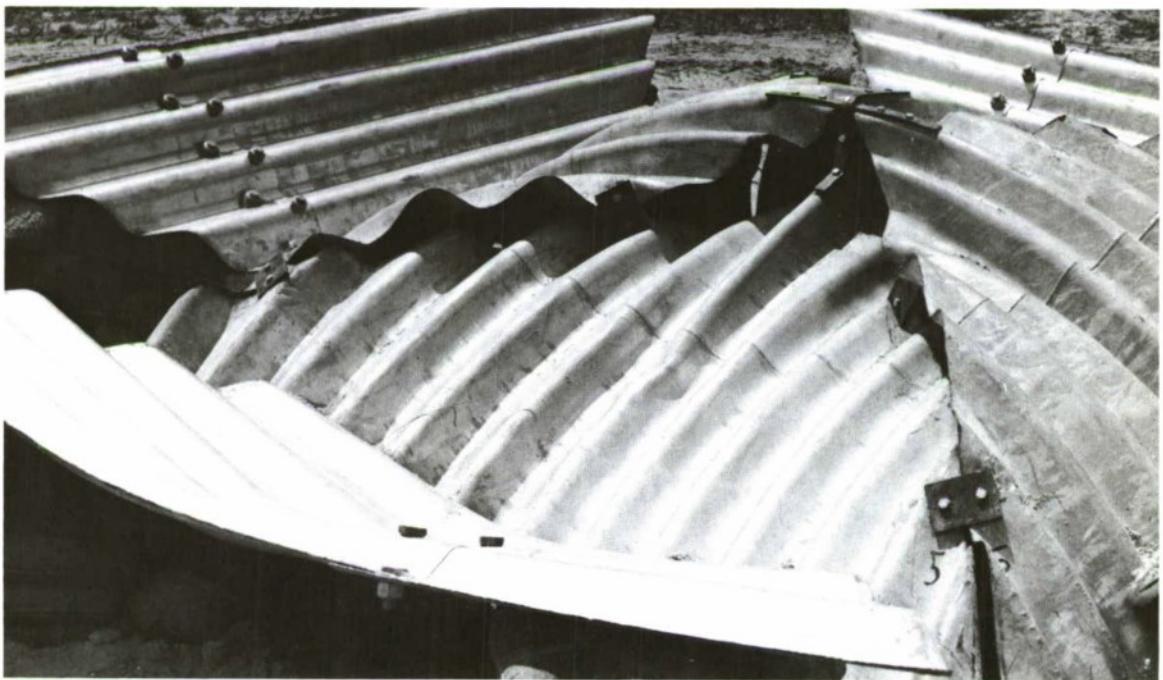
of MICS above which the 10-pound charge of TNT had been centered was depressed in relation to the other quarter-sections of MICS (Figure 4.6d). The crown end of the loaded quarter-section was displaced 5 inches (vertical) (Figure 4.6e) with its connecting steel strap bent and the nut end of one of its 3/8-inch bolts pulled through the corrugated metal. Shear failure occurred around the two sets of connecting plates located nearest the crown of the bunker. Figure 4.6f shows the typical shear failure that occurred around one set of connecting plates. The aperture beam had a permanent set that was a maximum of 7-3/4-inches along its center line (Figure 4.6g). The soil was removed from the base of the bunker, and it was observed that the base had punched into the ground approximately 7 inches near the aperture of the quarter-section where the 10-pound charge was centered (Figure 4.6h). This, of course, was a cumulative result of all three rounds.

d. Depression of loaded side of MICS

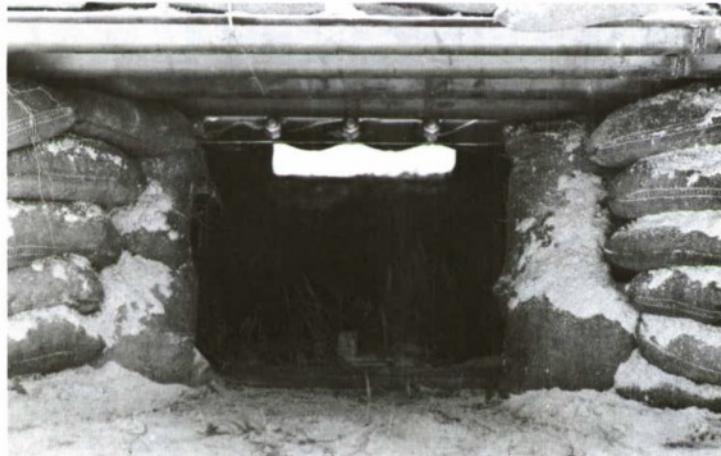
4.3.4.1 Round 1. There was no visible damage to the bunker as a result of the 10-pound spherical TNT charge detonated above its crown. The crater (Figure 4.11a) was geometrically similar to that of the 4-pound crown shot (Round 1) of the Phase I test series, only larger. The apparent crater was 7 feet in diameter and had four peaks, each

c. Typical unaffected firing port

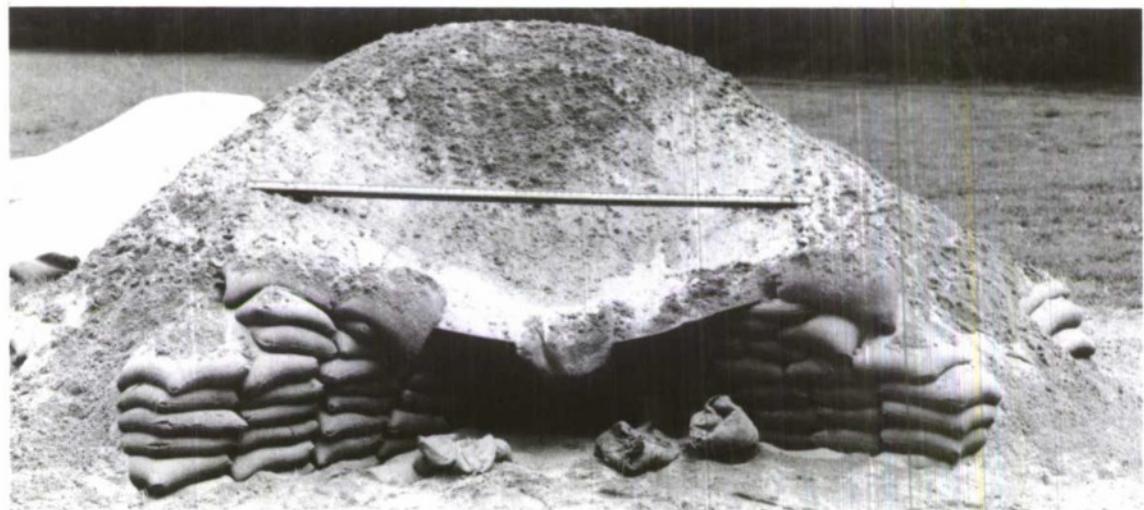
4.3.4.2 Round 2. The apparent crater formed by the detonation of the 10-pound charge on the side of MICS appeared to be 7 feet in diameter (Figure 4.12a) and 9-1/2 inches deep (Figure 4.12b). However, the actual crater dimensions were impossible to determine due to the back-slide of loose sand.

a. Apparent crater diameter was 7 feet

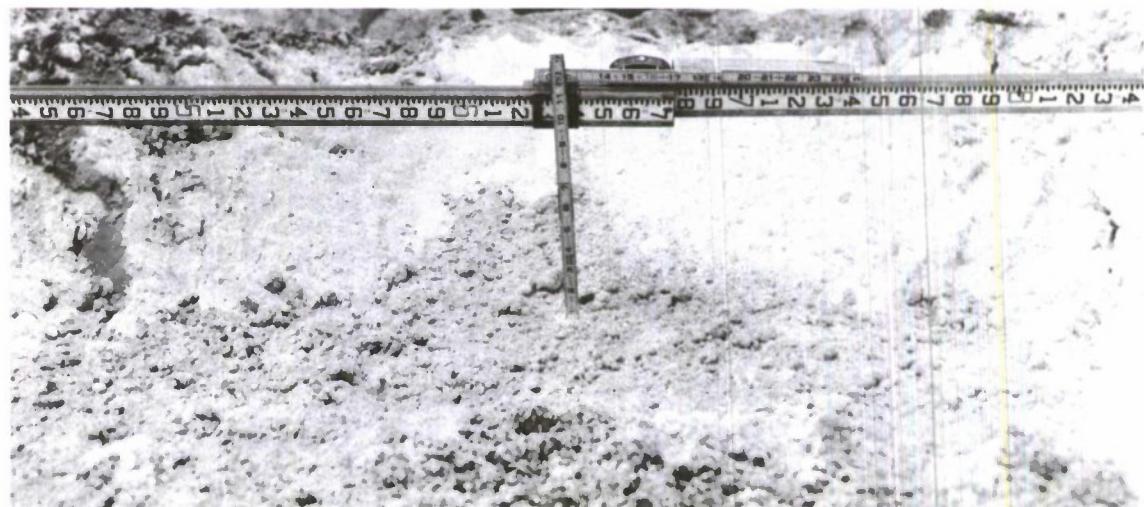
b. Apparent crater depth was 9-1/2 inches

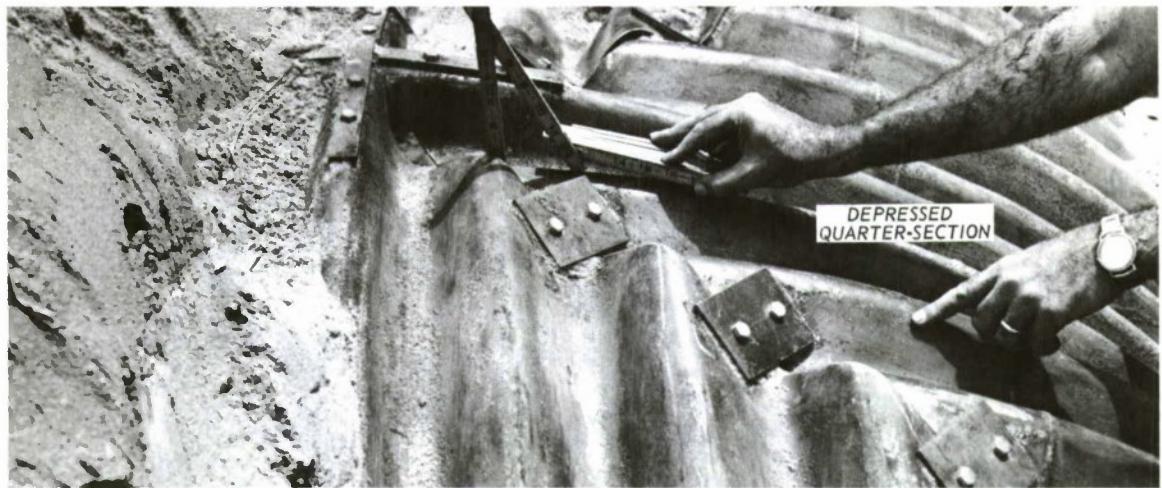
It was apparent after removing the sand cover that the additional steel plates and straps used to connect the quarter-sections prevented the distortion evident during the Phase I test series. It was observed that the quarter-section of MICS above which the 10-pound charge was centered was slightly depressed in relation to the adjacent quarter-sections. This depression, a maximum of 1 inch measured vertically (Figure 4.12c), occurred between the crown and the steel-plate connectors nearest the crown. The aperture beam above which the 10-pound charge was centered sustained a permanent set that was a maximum of 11-1/2 inches along its center line (Figure 4.12d). Despite this failure, and due to the steel channel footings that prevented the loaded quarter-section from punching into the ground surface, the embrasure could still be used as an emergency exit and/or as a firing port that would not require a vertical angle.

c. Depression of loaded quarter-section of MICS

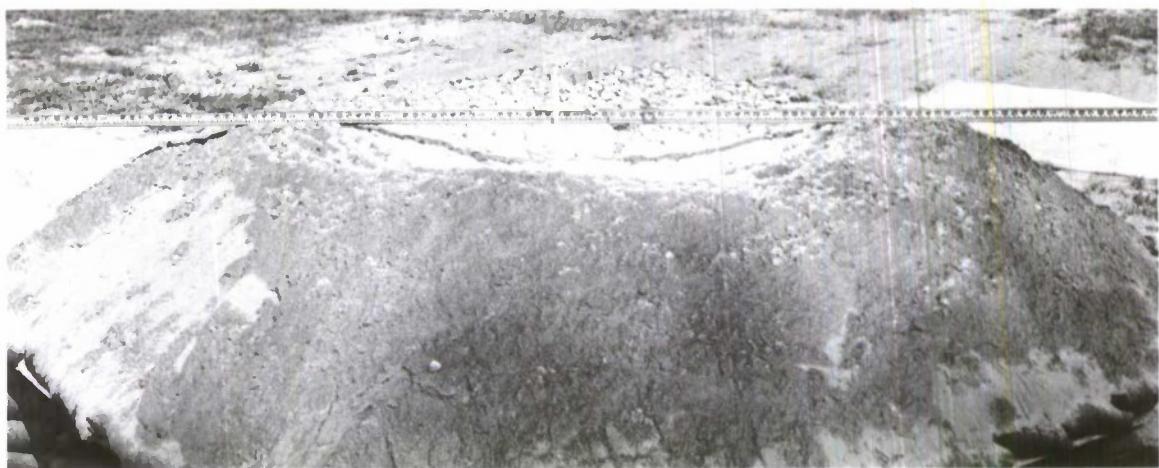
4.4.4.1 Round 1. There was no visible damage to the bunker as a result of the 4-pound spherical TNT charge detonated above its crown. The apparent crater (Figure 4.16a) was similar to that of Round 1 of the Phase I test series (Section 4.2.3.1). Also, like Round 1 of the Phase I test series, a mound of sand was deposited in front of each firing port (Figure 4.16b).

a. Apparent crater

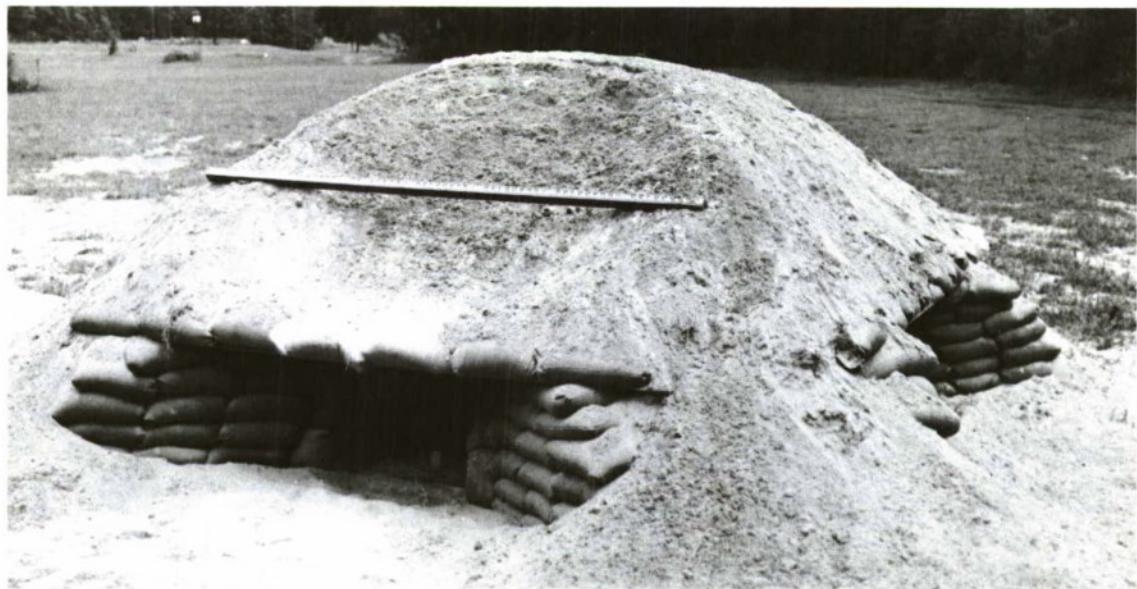
4.4.4.2. Round 2. Other than the displacement of some of the sand cover, there was no visible damage to the bunker as a result of the 4-pound spherical TNT charge detonated on the side of MICS. The apparent crater (Figure 4.17a) appeared to be similar to that of Round 2 of the Phase I test series (Section 4.2.3.2).

a. Crater formed by Round 2

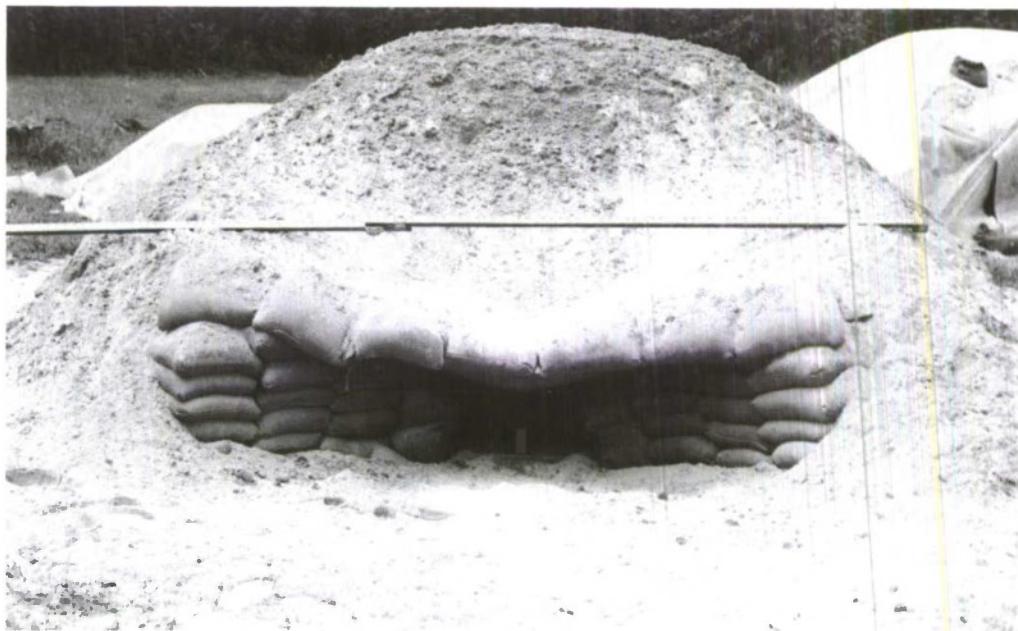
4.4.4.4. Round 4. The apparent crater (Figure 4.18a) of the 10-pound charge on the side of MICS was similar to that of Round 2 of Phase II test series (Section 4.3.4.2). It was apparent, after removing the sand, that the aperture beam above which the 10-pound charge was centered sustained a permanent set of 11-1/2 inches along its center line (Figure 4.18b). This was equal to the permanent set sustained by the aperture beam due to Round 2 of the Phase II test series. The embrasure formed by the damaged aperture beam could still be used as an emergency exit and/or as a firing port that would not require a vertical angle. It was also observed after removing the damaged aperture beam that a permanent set of 5-1/4 inches had occurred at the center line of the quarter-section of MICS about which the 10-pound charge had been centered (Figure 4.18c). It was also evident that the center corrugation of the two adjacent quarter-sections to the loaded quarter-section had been compressed due to

a. Apparent crater

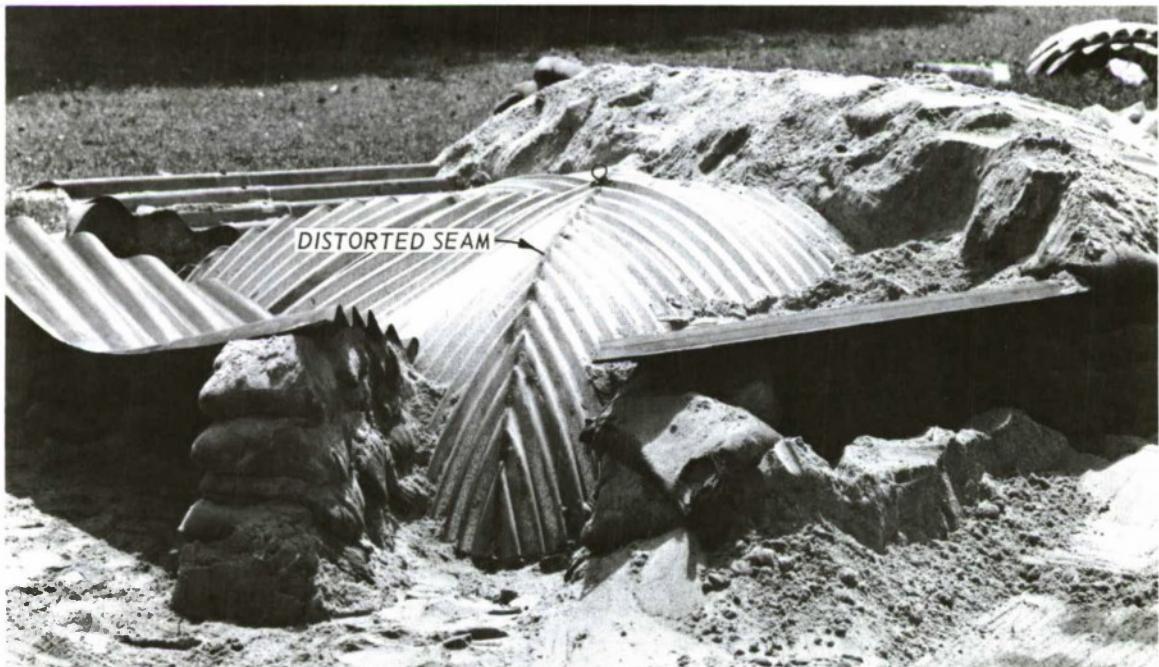
d. Typical distorted seam
